March Monthly Compliance Report

Solid Waste Permit #498
Bristol Integrated Solid Waste Management Facility
2655 Valley Drive
Bristol, VA 24201
(276) 645-7233

02218208.05-18 | April 10, 2023

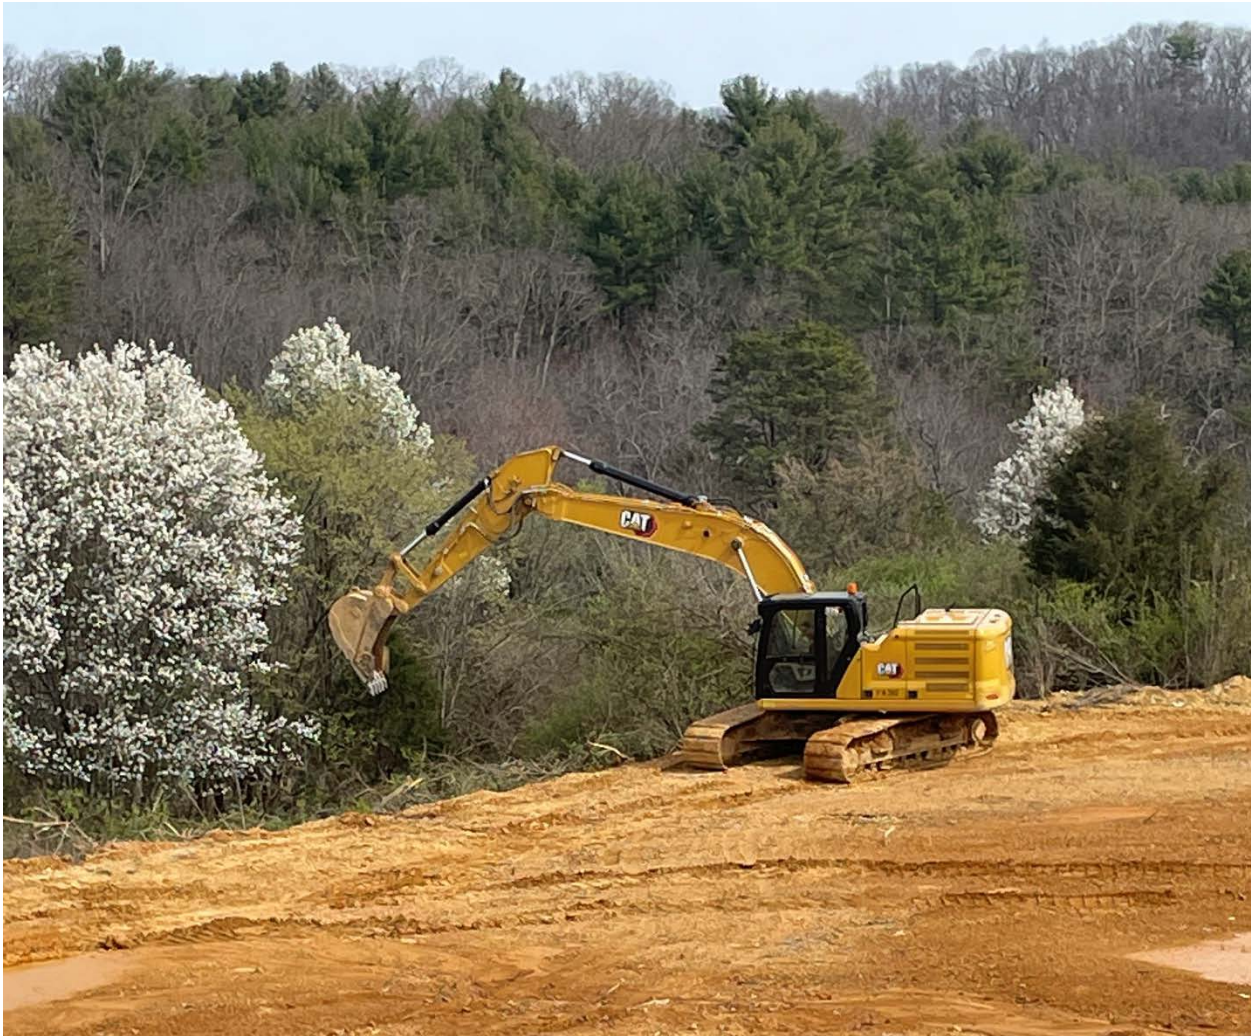
Figure 1. Removal of Vegetation from Landfill Side Slopes

month of March the City was able to clear slopes to begin the process of placing additional intermediate cover. A photo of City staff clearing vegetation from the slopes of the SWP #498 Landfill is shown in Figure 1. During the month of April the City will perform a soil thickness verification investigation to determine if any areas of the landfill need additional soil cover.

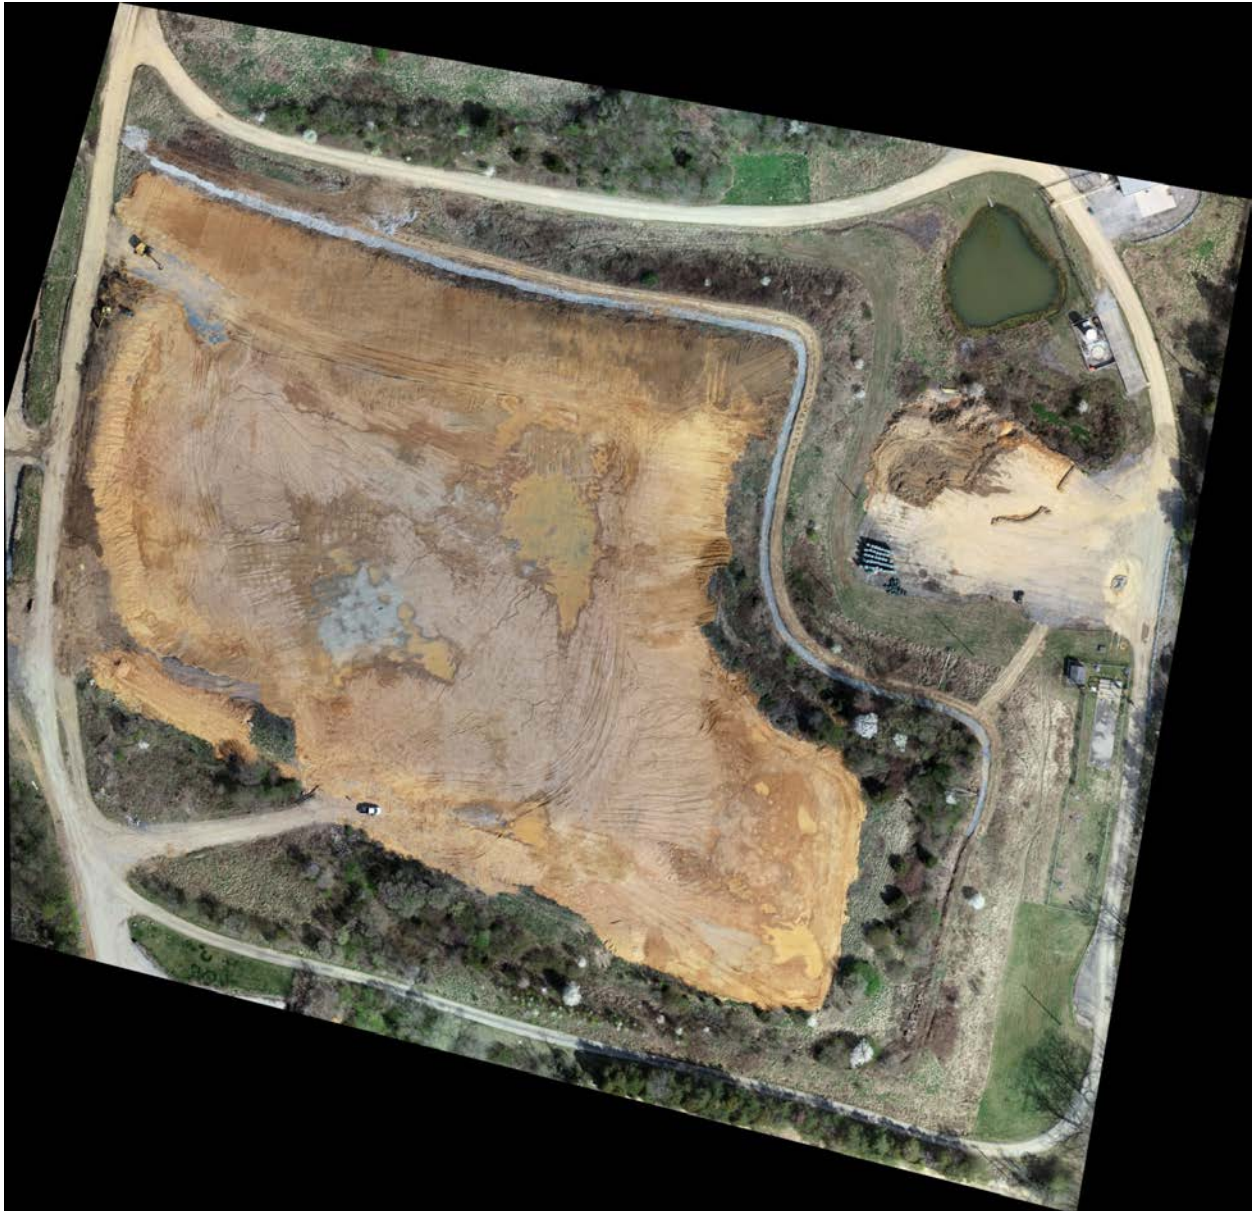
Figure 2. Aerial Photo of the SWP #498 Landfill

The City, through SCS, collected topographic data of the SWP #498 Landfill using photogrammetric methods via an unmanned aerial vehicle (UAV or drone). On March 9, 2023 the flight was completed and the topographic data collected. A composite photo of the landfill generated from data collected during the flight is show in Figure 2. The additional topographic data will allow SCS to estimate the impacts of intermediate cover soil volumes on the final grading plan.

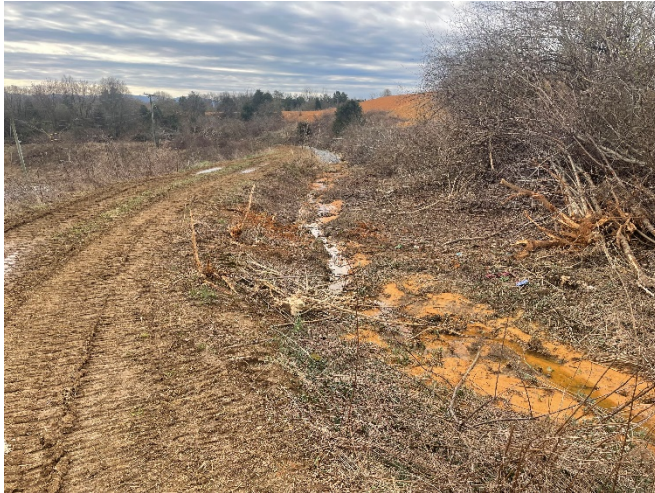
Stormwater diversion channel and trench berm prior to clean-out and stabilization.

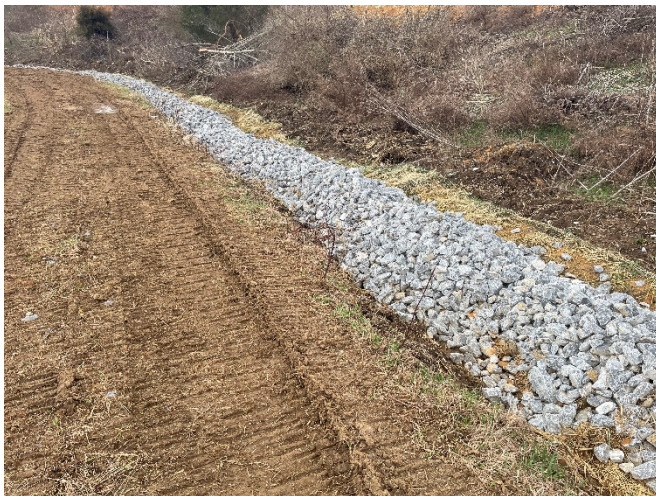
Stormwater diversion channel and trench berm with sediment removed, erosion control matting in place, and aggregate placed.

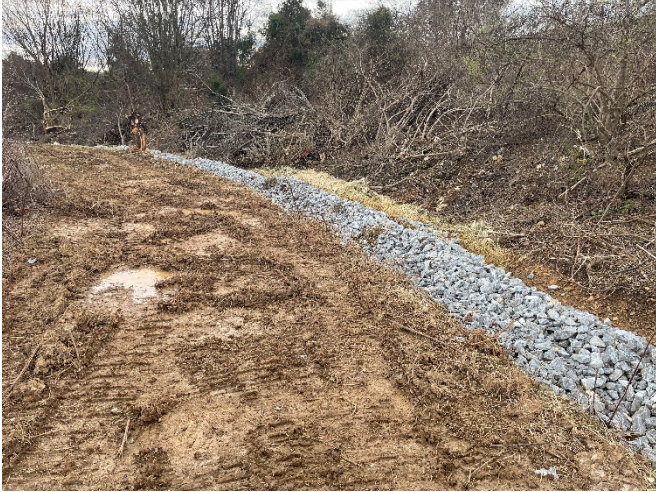
Stormwater diversion channel and trench berm with sediment removed, erosion control matting in place, and aggregate placed.

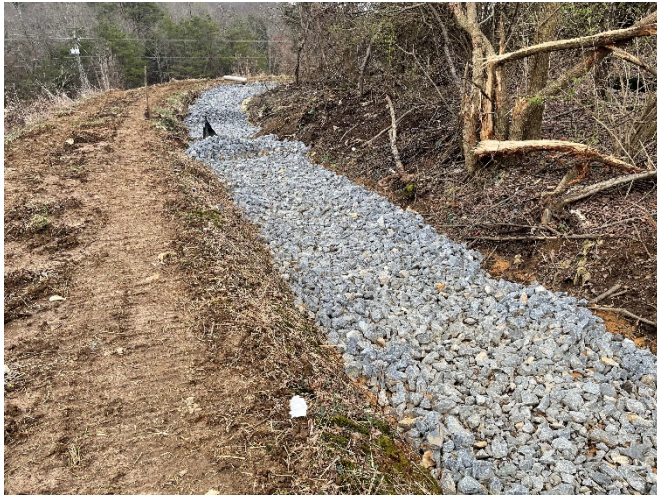
Stormwater diversion channel and trench berm with sediment removed, erosion control matting in place, and aggregate placed & spread.

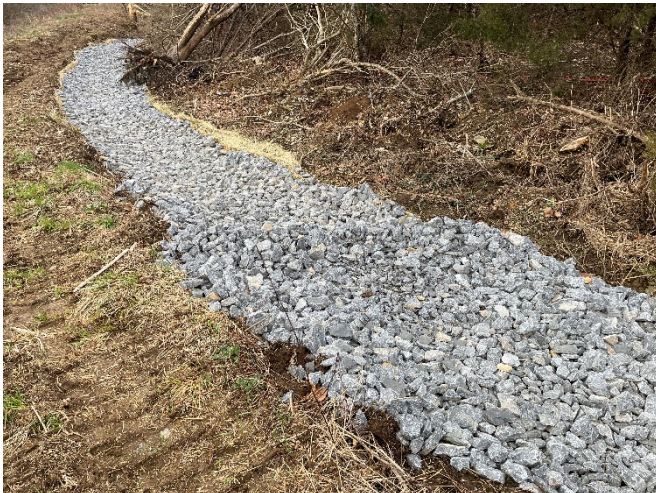
Stormwater diversion channel and trench berm with sediment removed, erosion control matting in place, and aggregate placed & spread.

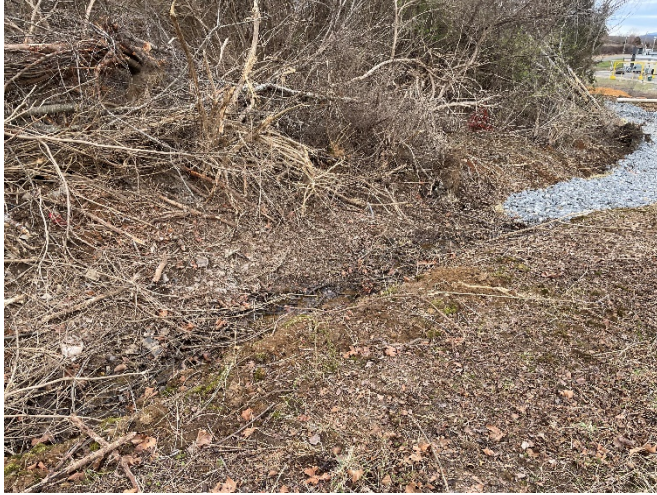
Stormwater diversion channel and trench berm prior to clean-out and stabilization.

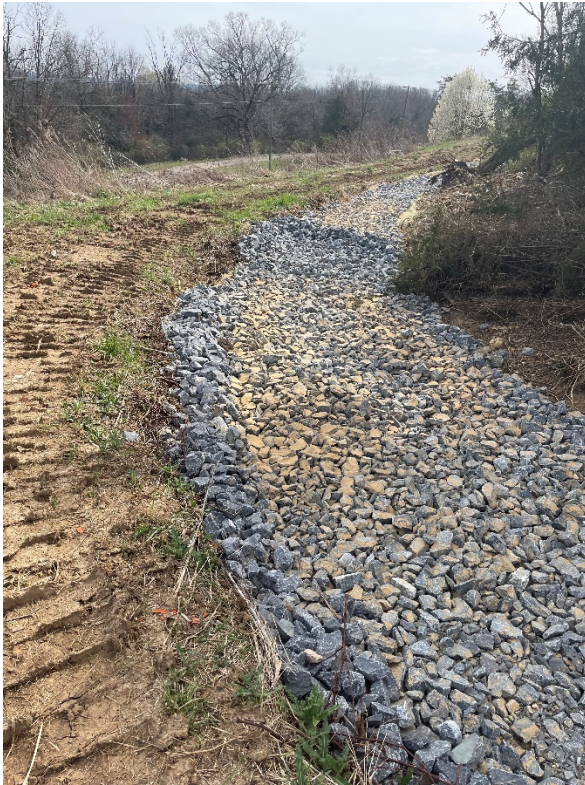
Stormwater diversion channel and trench berm with sediment removed, erosion control matting in place, and aggregate placed & spread.

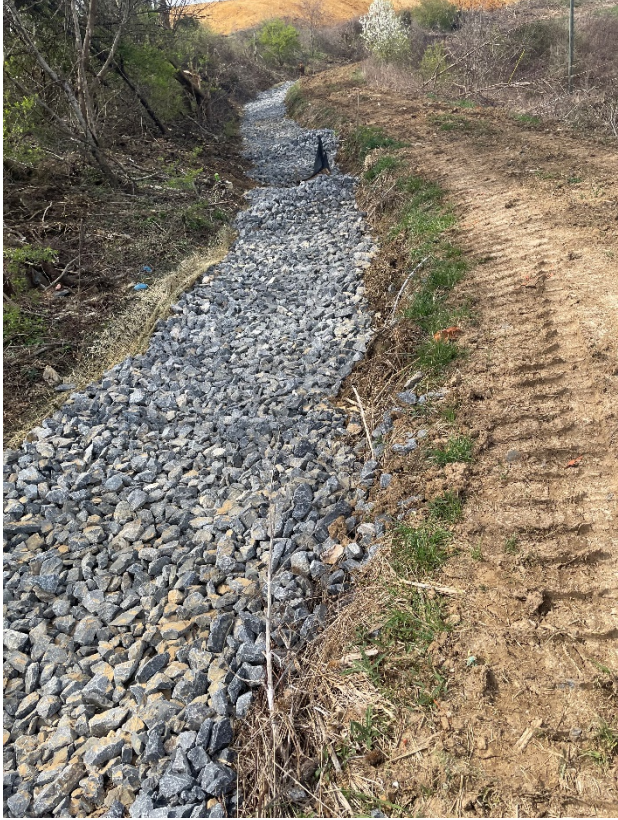
Stormwater diversion channel and trench berm with sediment removed, erosion control matting in place, and aggregate placed & spread.

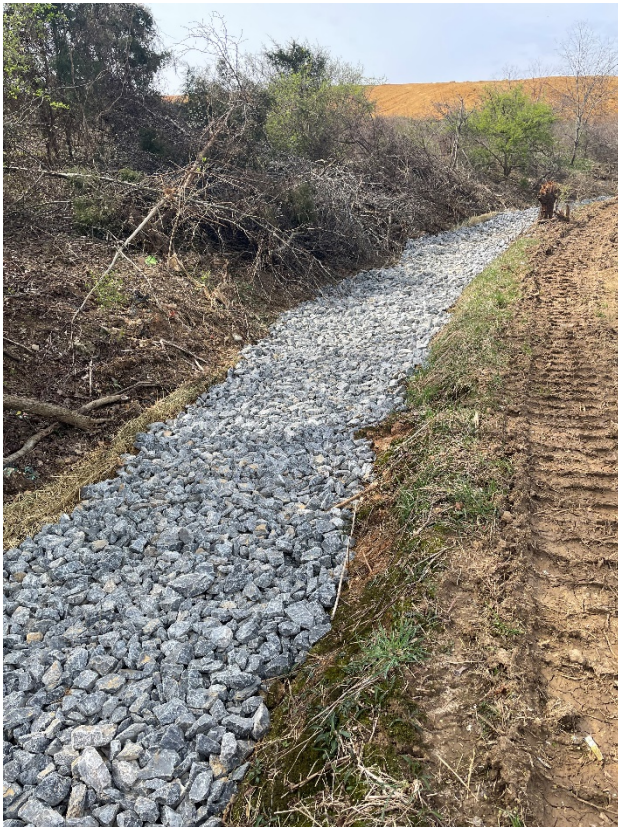
Stormwater diversion channel and trench berm with sediment removed, erosion control matting in place, and aggregate placed & spread.

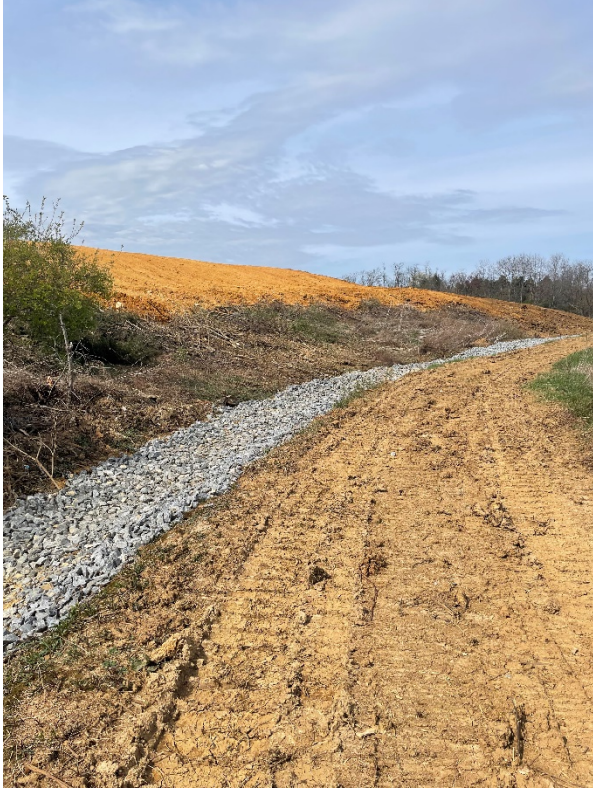
Stormwater diversion channel and trench berm with sediment removed, erosion control matting in place, and aggregate placed & spread.

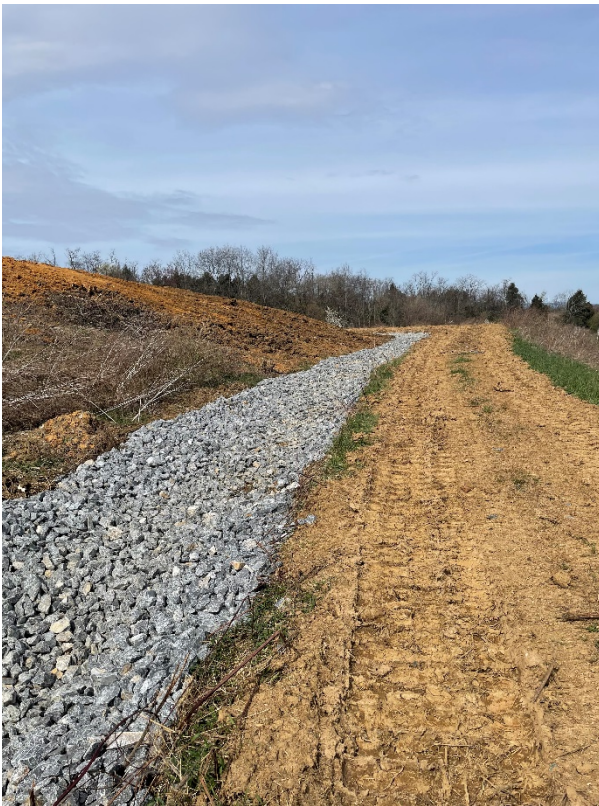
Stormwater diversion channel and trench berm with sediment removed, erosion control matting in place, and aggregate placed & spread.

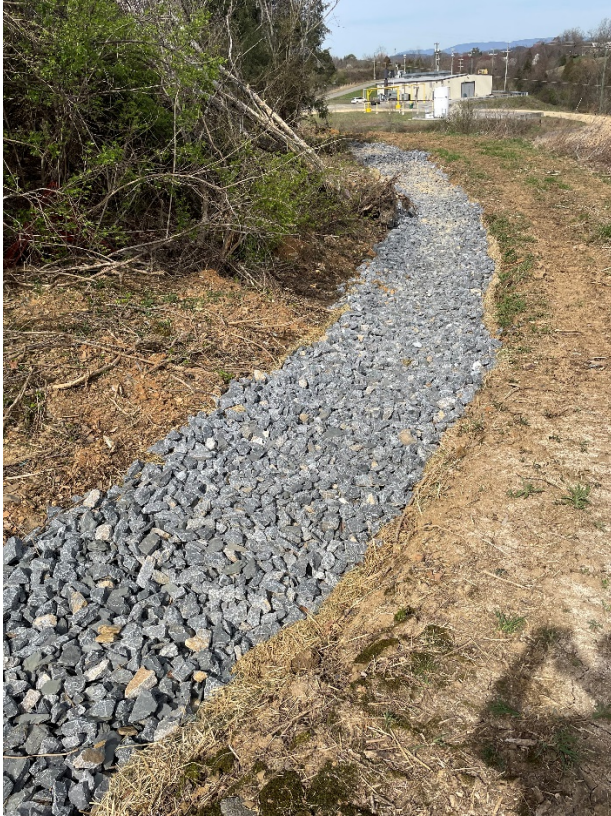
Stormwater diversion channel and trench berm with sediment removed, erosion control matting in place, and aggregate placed & spread.

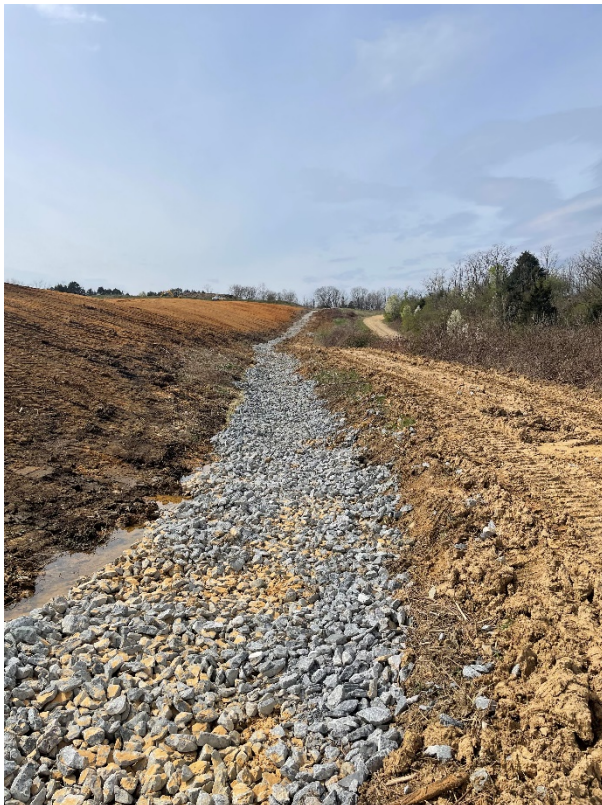
Stormwater diversion channel and trench berm with sediment removed, erosion control matting in place, and aggregate placed & spread.
