# January Monthly Compliance Report

Solid Waste Permit #221  
Bristol Integrated Solid Waste Management Facility  
2655 Valley Drive  
Bristol, VA 24201  
(276) 645-7233

02218208.05-18 | February 10, 2023

# Landfill Gas Collection and Control System Optimization Results

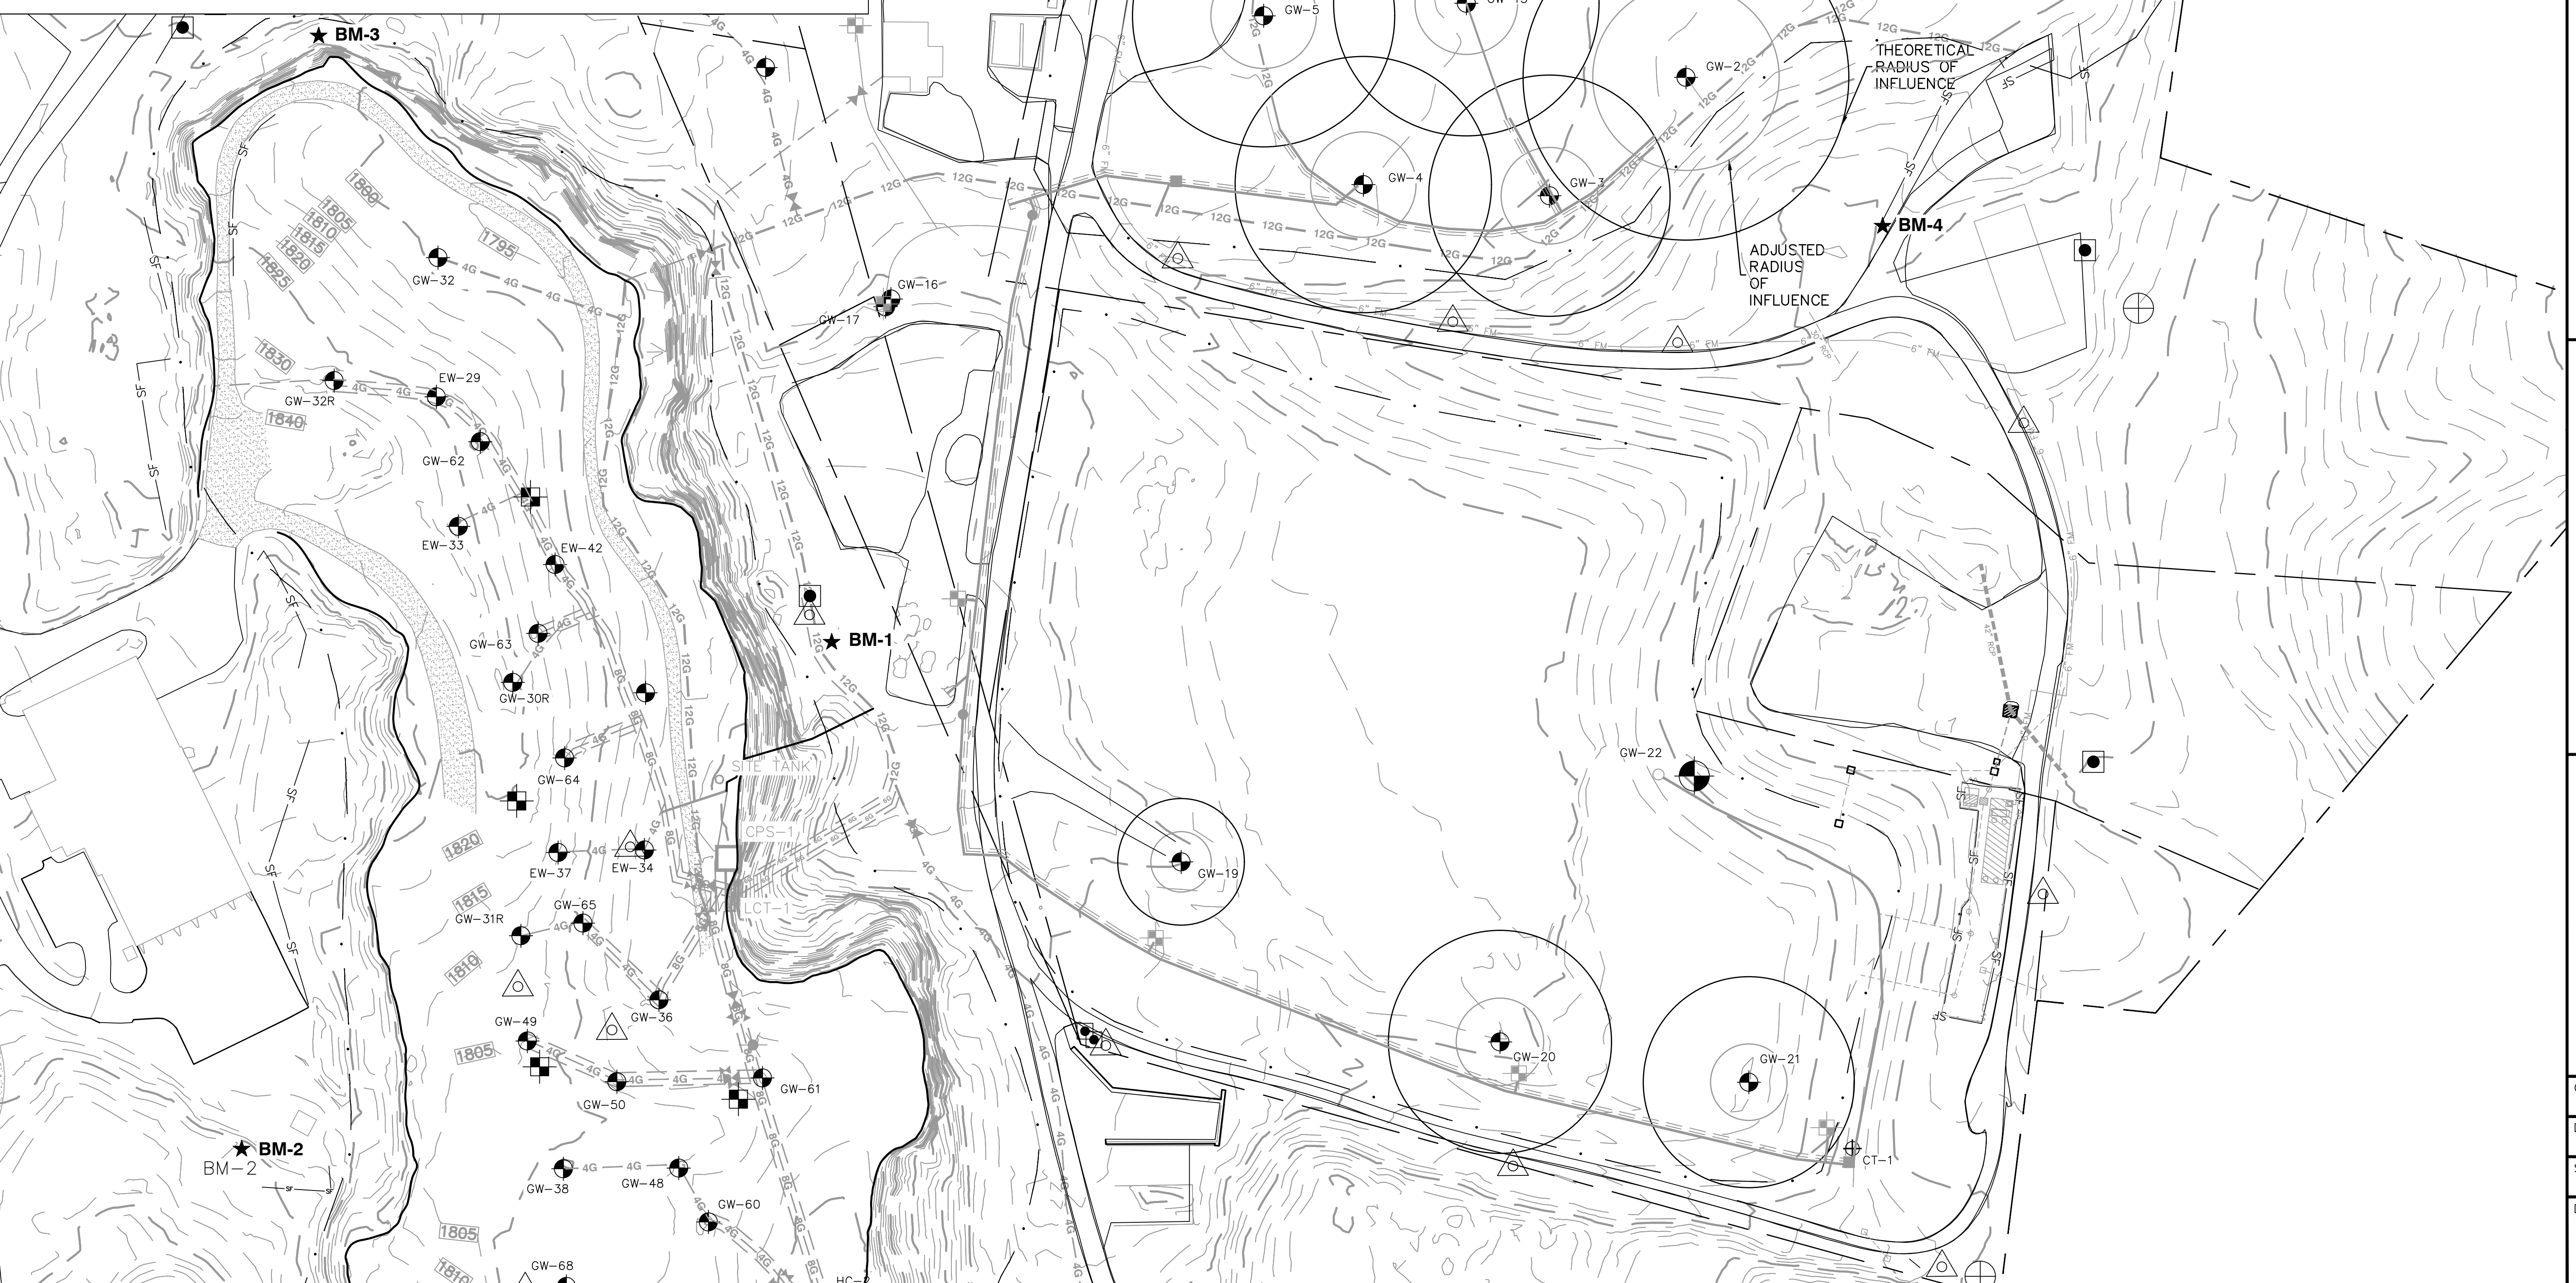
SHEET TITLE  
**RADIUS OF INFLUENCE MAP**

SCS developed a theoretical zone of influence at each vertical LFG well in the Permit #221 Landfill, using the current depth measured by field personnel, multiplied by a value of 3 to obtain a radius, then translating the radius into a circular area to assess the “horizontal” coverage of the LFGCCS. In order to assess the potential influence of liquids in LFG collection capacity, an adjusted radius and circle were calculated by only accounting for depth that is not structurally impaired or blocked by liquids.

A map of coverage areas based on the theoretical and adjusted zones of influence is included in Appendix D. The results of this exercise indicate that the current wellfield has been designed with appropriate coverage. Many of the zones of influence are overlapping and there are very few gaps in coverage. The adjusted zones of influence show some opportunity to increase coverage through dewatering activities.
