February Monthly Compliance Report

Solid Waste Permit #498
Bristol Integrated Solid Waste Management Facility
2655 Valley Drive
Bristol, VA 24201
(276) 645-7233

02218208.05-18 | March 10, 2023

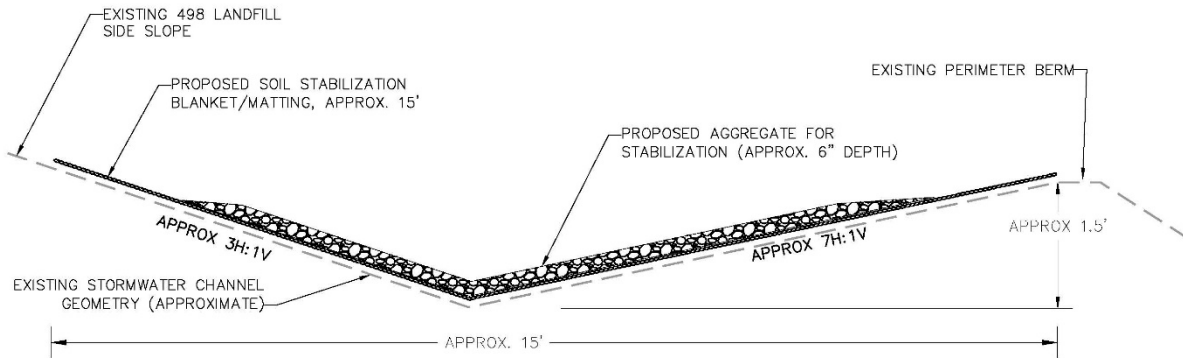
Figure 1. Stormwater Diversion Channel/Trench Berm Stabilization

The City has completed clean-out of the stormwater diversion channel/trench berm. The sediment deposited in the channel has been removed. Erosion control matting was placed in the channel to apply stabilization. Drainage aggregate was placed on top of the erosion control matting to anchor

the matting and provide addition stabilization. Figure 1 below shows a cross sectional view of the general arrangement of the stabilization features.

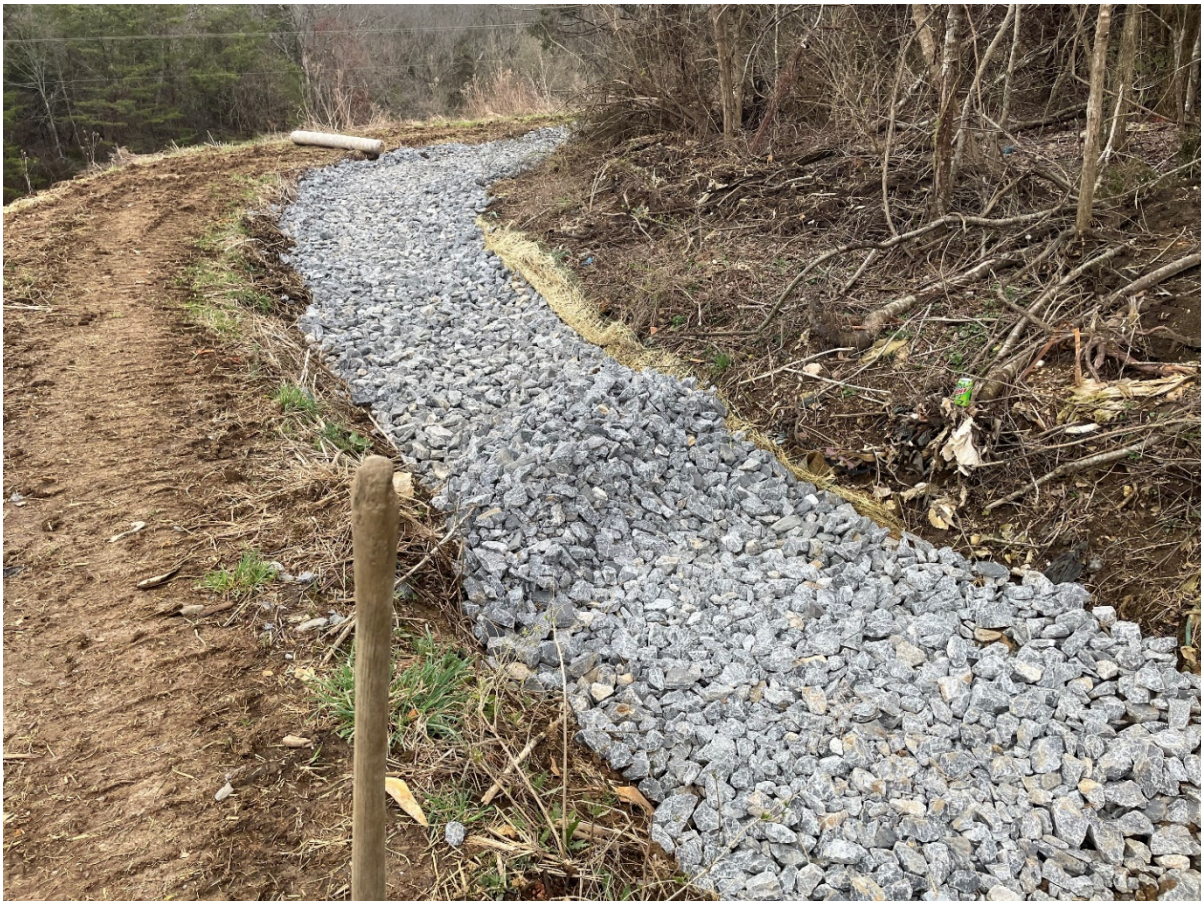
Figure 2. Stormwater Diversion Channel/Trench Berm Work Progress

SCS Engineers conducted a site visit on February 24, 2023 to observe progress on the Stormwater Diversion Channel/Trench Berm Repairs. Figure 2 depicts the progress of work on the channel observed during that site visit.
